## Biological Deterioration of Calcarenite by *Caloplaca* Lichens at Sabratha Archaeological Site, NW Libya

**Abstract:** This study investigates the impact of biological weathering on Roman and Byzantine calcarenite monuments at the Sabratha archaeological site in Libya, specifically focusing on colonization by *Caloplaca* lichen species. Comparative analysis of total carbonate content between fresh and weathered stone samples was conducted using insoluble acid residue experiments. The results revealed a significant reduction in calcite content in weathered samples compared to fresh ones. Furthermore, petrographic observations of thin sections indicated that fresh calcarenite building stones are characterized by dominant calcite cement, whereas weathered samples show substantial degradation of the stone fabric. These findings highlight the critical role of lichen-induced biodeterioration in the irreversible loss of Mediterranean cultural heritage.

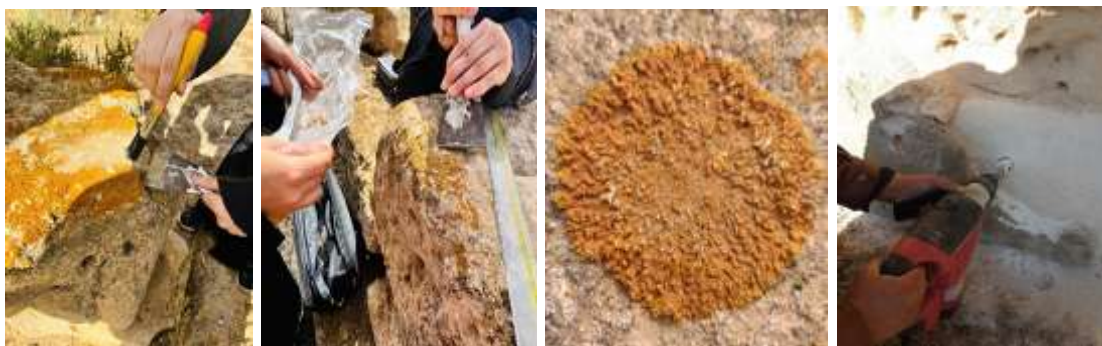
Figure( 2 ) Sample collection

Due to the study area is archaeological site only Five fresh calcarenite samples and five weathered samples (colonized by *Caloplaca* colonies) were collected from Roman villa, the Theater within the Sabratha ruins (Fig1-b). Care was taken to ensure that sampling did not aesthetically damage the site (Fig-2).

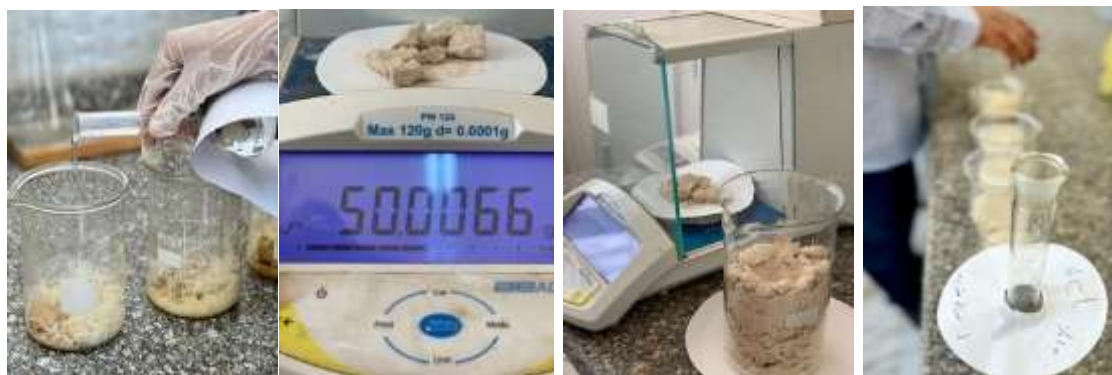
Figure (3) Laboratory analysis

- **Petrographic Analysis:** Thin sections (0.003 mm thickness) were prepared and examined under a polarized microscope to describe texture, mineral composition, and porosity.
- **Carbonate Content Determination:** The insoluble acid residue method was employed using 10% dilute hydrochloric acid (HCl) to quantify the difference in calcium carbonate content between fresh and weathered samples (Fig 3)
